PROJECT: **BID NO. NC21-008**  
**Board of County Commissioners, Nassau County, FL (OWNER)**  
**South Amelia Island Dredging & Beach Nourishment Project**

**2000 AGREEMENT**  
**FOR**  
**BID NO. NC21-008 SOUTH AMELIA ISLAND**  
**DREDGING & BEACH NOURISHMENT PROJECT**

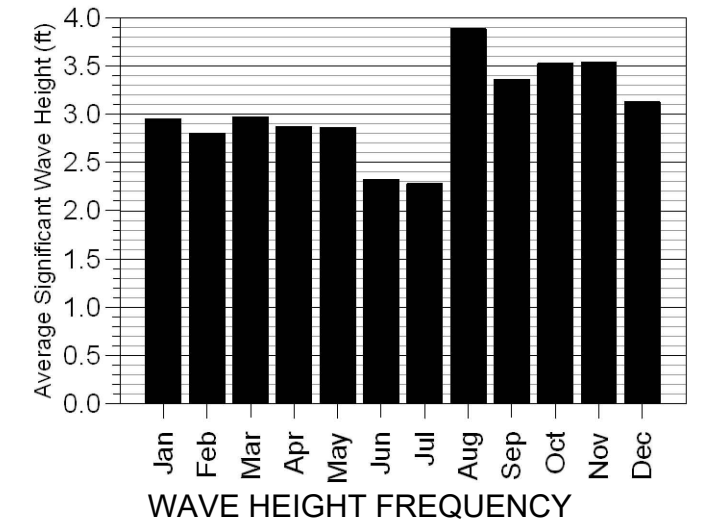
Data Source:  
NDBC Buoy 41112  
Years 2008-2020  
Offshore Fernandina Beach, FL  
30.709 N 81.292 W  
Water Depth: 51.0 ft

- 1) ALL ELEVATIONS ARE RELATIVE TO FEET-NAVD 88, UNLESS OTHERWISE NOTED
- 2) WAVE CONDITIONS AT SITE MAY VARY FROM REPORTED BUOY CONDITIONS. WAVE CLIMATE DATA PRESENTED FOR GENERAL INFORMATION PURPOSES ONLY.
